## **APPENDIX C**

### **Site Photographs - Excavation**

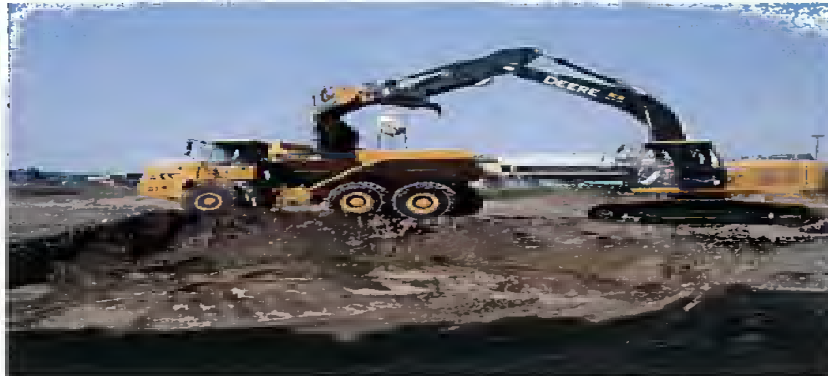
8/3/06 – Excavation of Maintenance Area soil, looking north.

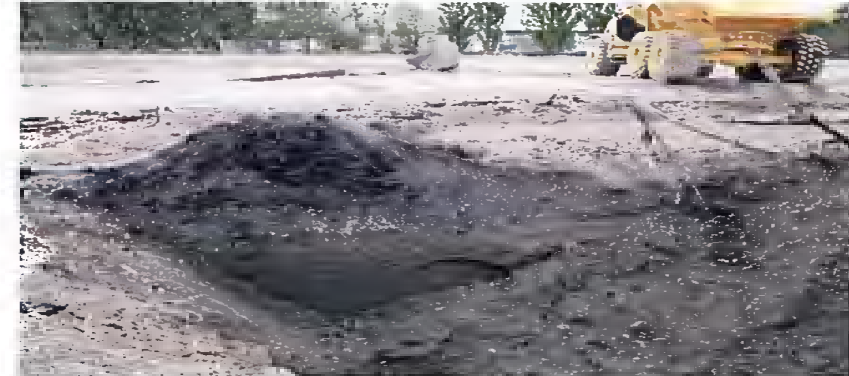
8/1/06 – Deep Compressor Area excavation, looking southeast. Note green coloration in surface soil.

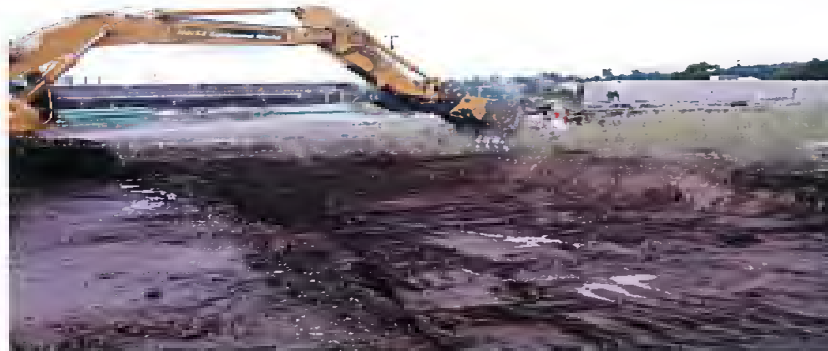
8/9/06 – Excavation of Compressor Area, looking northeast.

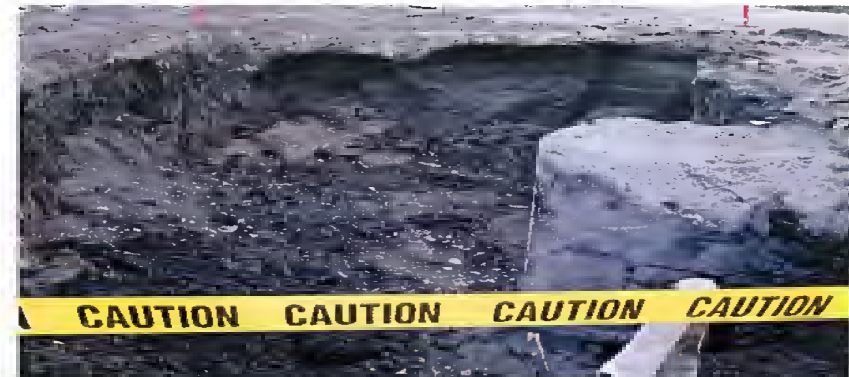
8/7/06 – Deep Compressor Area excavation, looking north. Note seep in northwest corner and concrete vault at east of excavation.

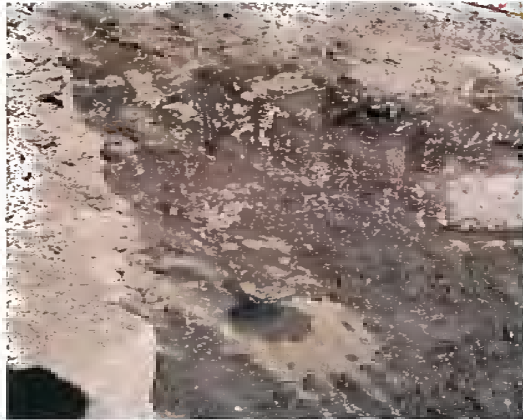
8/8/06 – Deep Compressor Area excavation, northwest corner. Note seep emanating from ~4 feet bgs.

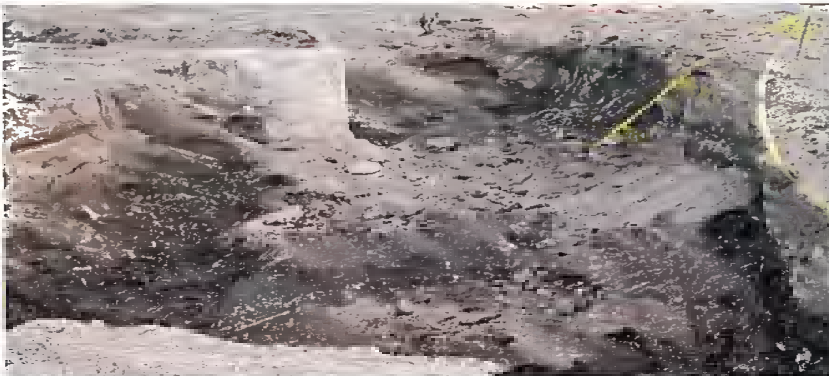
8/9/06 – Deep Compressor Area excavation, looking south. Note concrete cistern in left background.

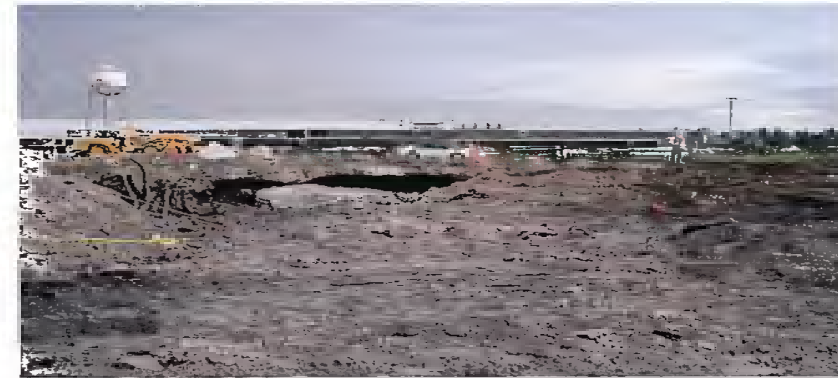
8/10/06 – Deep Compressor Area excavation, looking north from Maintenance Area.

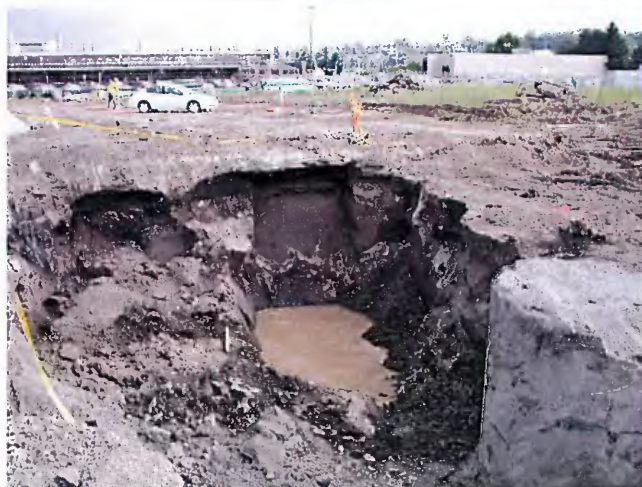
8/10/06 – Deep Compressor Area excavation looking north, after excavation and sampling. Note groundwater.

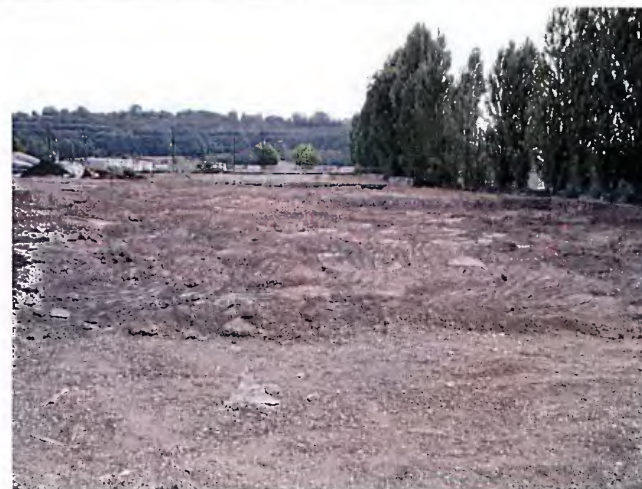
8/10/06 – Maintenance Area excavation, looking east after confirmation sampling. Note red sample location flags. Toluene affected soil stockpile in background left in the East Parcel.

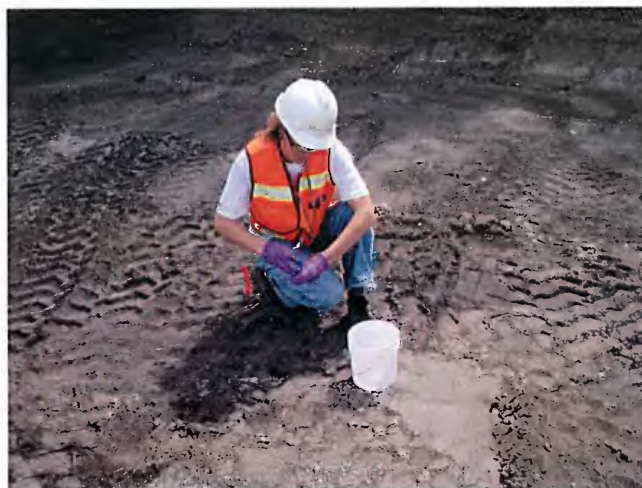
8/9/06 – Confirmation sampling. Note bucket for composite sample in foreground.

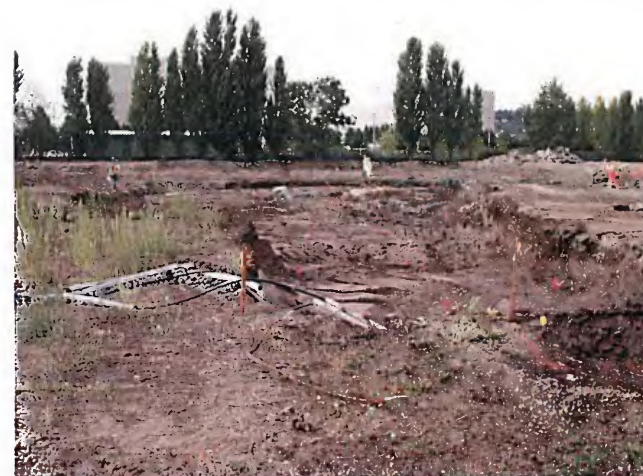
8/10/06 – Compressor Area excavation, looking south from south Sulfuric Acid Area. Note staked as-built corners of excavation, and red sample location flags.

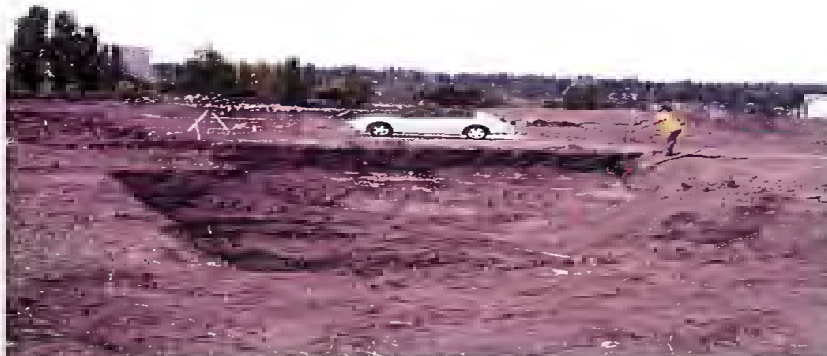
8/10/06 – South Sulfuric Acid Area after excavation and sampling, looking southwest.

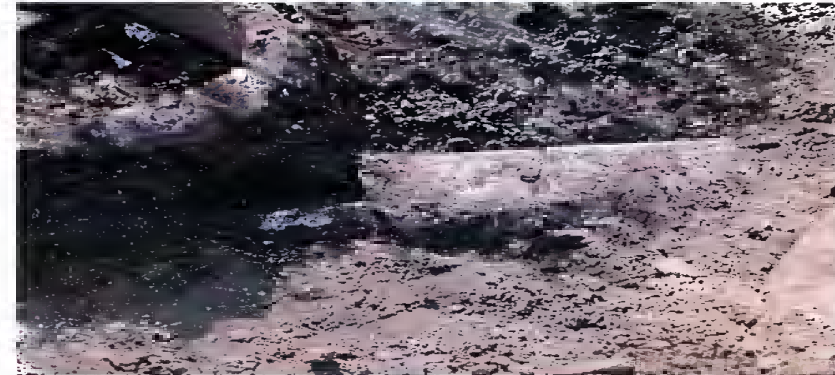
8/3/06 – Asbestos-containing pipe (sample PIPE-1) in north Maintenance Area (pipe is central left side of photo).

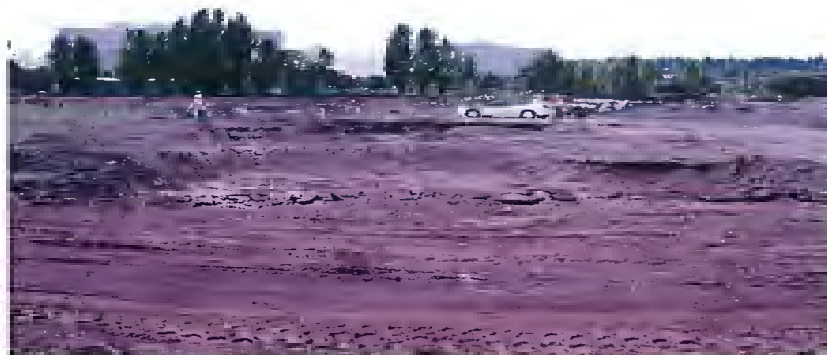
8/10/06 – GPS and level surveying, after excavation and sampling. Note red sample flags in excavations. Photo taken from north Sulfuric Acid Area, looking south.

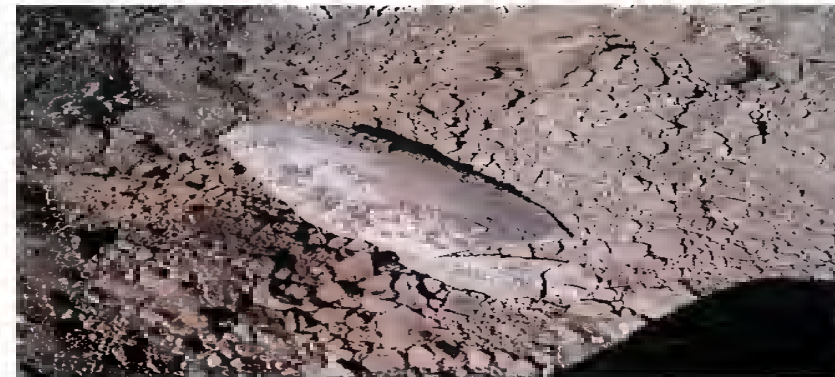
8/7/06 – Close-up of asbestos-containing pipe (PIPE-1) in north Maintenance Area.

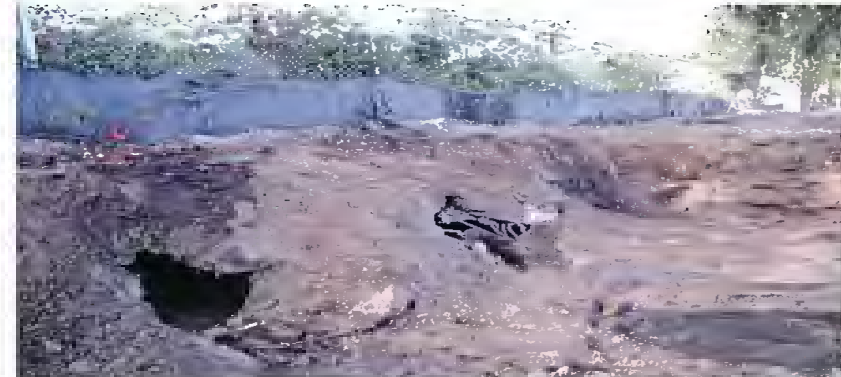
8/8/06 – Oil-water separator at south of Maintenance Area, looking southwest.

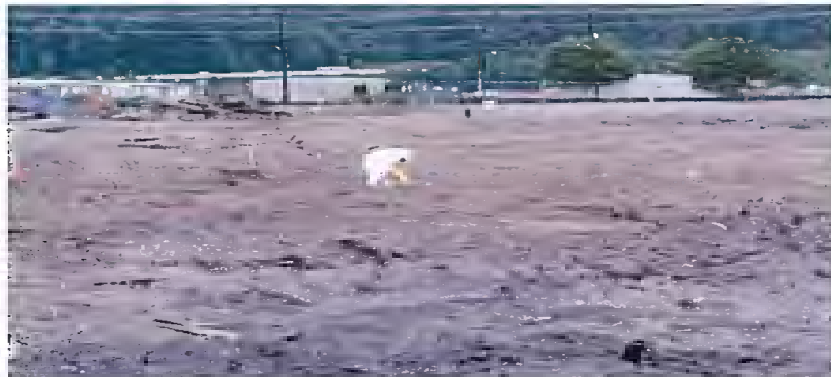
8/9/06 – Long Services asbestos abatement of loose asbestos pipe (PIPE-1).

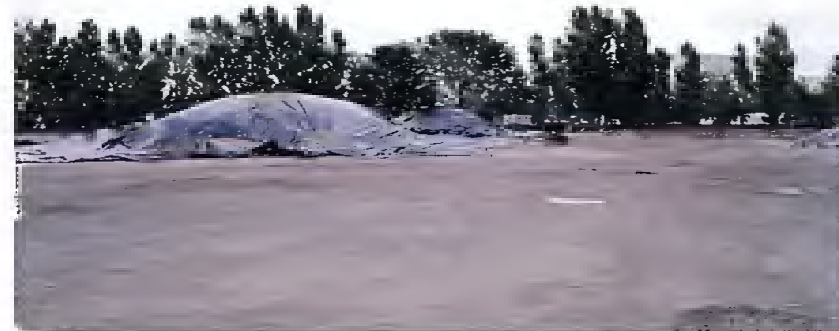
8/10/06 – Covered toluene-affected soil stockpile on East Parcel from Deep Compressor Area excavation.

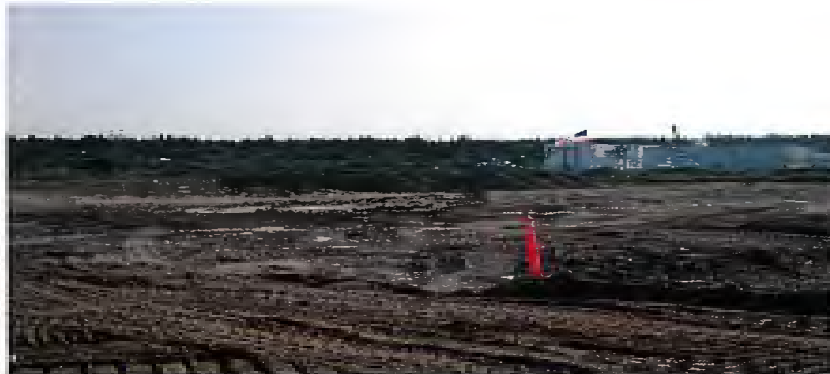
8/3/06 – West Parcel, looking southwest. Note stockpiles of excavated East Parcel soil in background within the barrier wall.

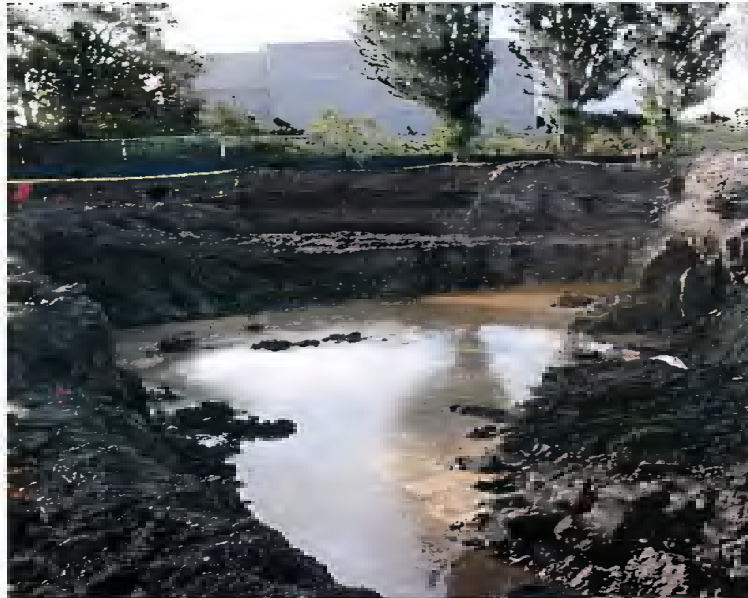
8/30/06 – Maintenance Area deep excavation,  
looking south (high tide).

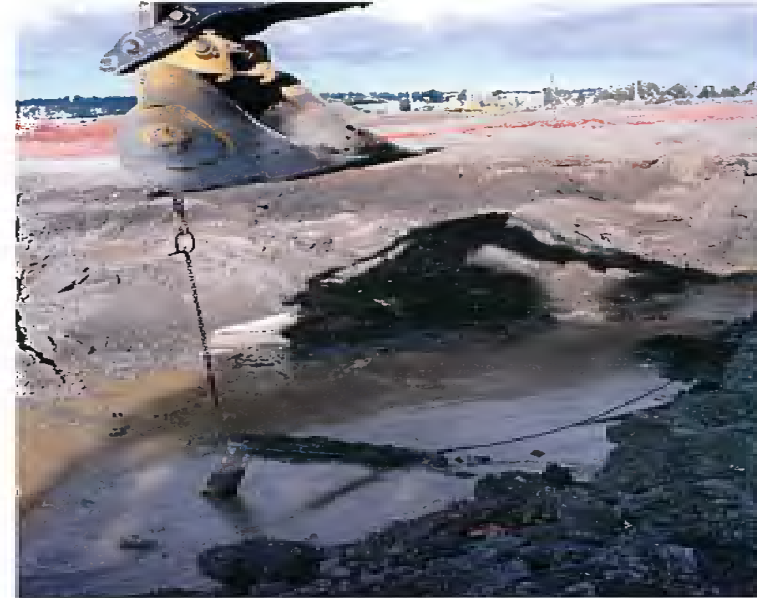
8/30/06 – Maintenance Area deep excavation,  
looking west during dewatering.
